# Bureau of Criminal Apprehension

## Fence at BCA Headquarters Saint Paul

For Variance to 63.314 Off Street Parking Facility Standards

January 5<sup>th</sup>, 2026

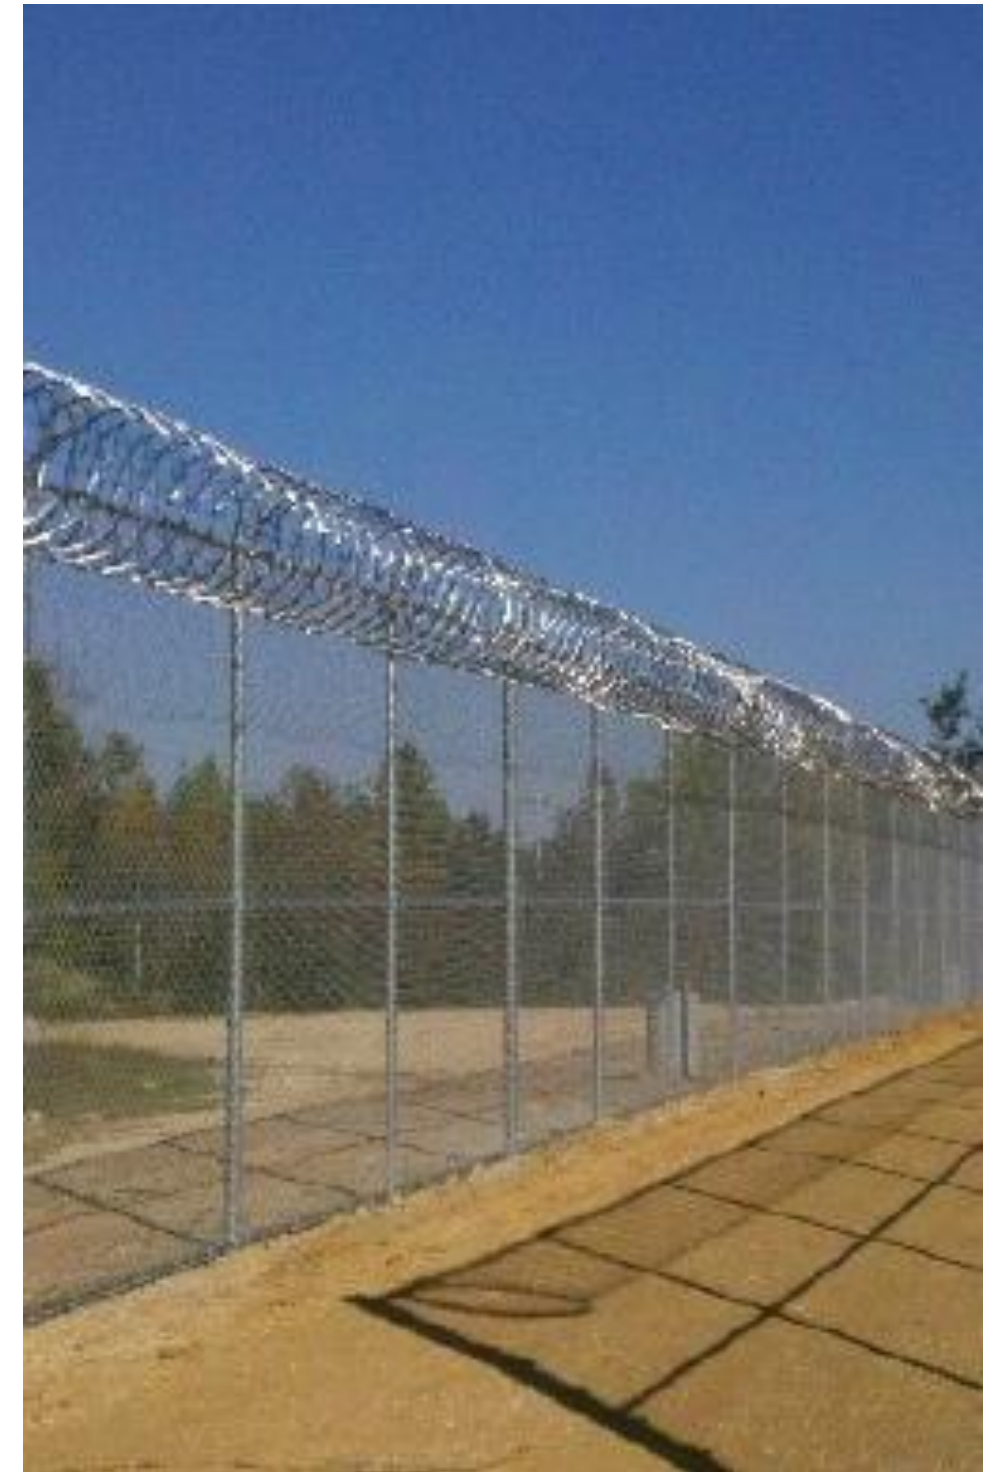
Typical Correctional Chain-link and razor wire, non-decorative security fence.
